HRSG Penetration Seal Inspection, Repair, And Replacement

Valtech Engineering is increasingly supporting CoGen turn-arounds with our penetration seal and fabric expansion joint capabilities.

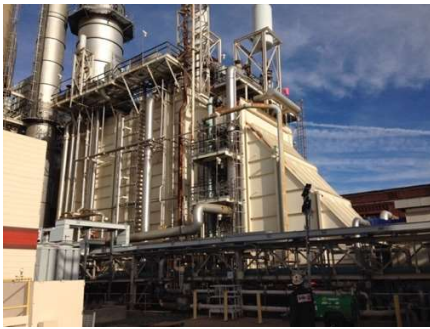
Our most recent CoGen revamp project was for a major refinery on the Texas gulf coast. In anticipation of the maintenance event Valtech's field engineers inspected 20 penetration seals on top of the CoGen HRSG unit and 30 on the bottom. Sixteen seals were identified as in dire-need of repair and/or replacement. Over 10 days, out of the longer turn-around schedule, Valtech's field-service crew arrived with parts, equipment and replaced all 16 damaged seals at a steady pace. A surprise arose when a 17th seal sustained mechanical damage due to maintenance work occurring nearby. The Valtech team was able to quickly

engineer a proper repair, expedite required parts/materials and make the repair comfortably within the site's schedule.

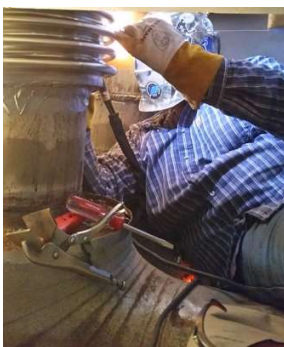
What is a pen-seal? Penetration-seal is an industry term used to describe the bellows elements that seal the HRSG headers to the units outer-casing. Where those headers pass in and out of the casing there is a circumferential gap around each pipe that allows the internal process and temperature to leak out and thereby measurably erode performance of the CoGen unit. It is important to ensure pen-seals remain leak-free and in good repair to guarantee name-plate performance of the unit. If the leaks are substantial enough it can dictate an unplanned shutdown and repair of the unit.

HRSG penetration seals have an average lifespan of 8-10 years in service. Failure modes include: cycle life failure, corrosion failure, and mechanical damage. To maintain efficiency as well as safety it is important to understand the condition of your penetration seals and how to repair or replace before a scheduled maintenance window.
